TECHNICAL NOTE 3190

FATIGUE INVESTIGATION OF FULL-SCALE
TRANSPORT-AIRPLANE WINGS

SUMMARY OF CONSTANT-AMPLITUDE TESTS THROUGH 1953

By M. J. McGuigan, Jr., D. F. Bryan, and R. E. Whaley

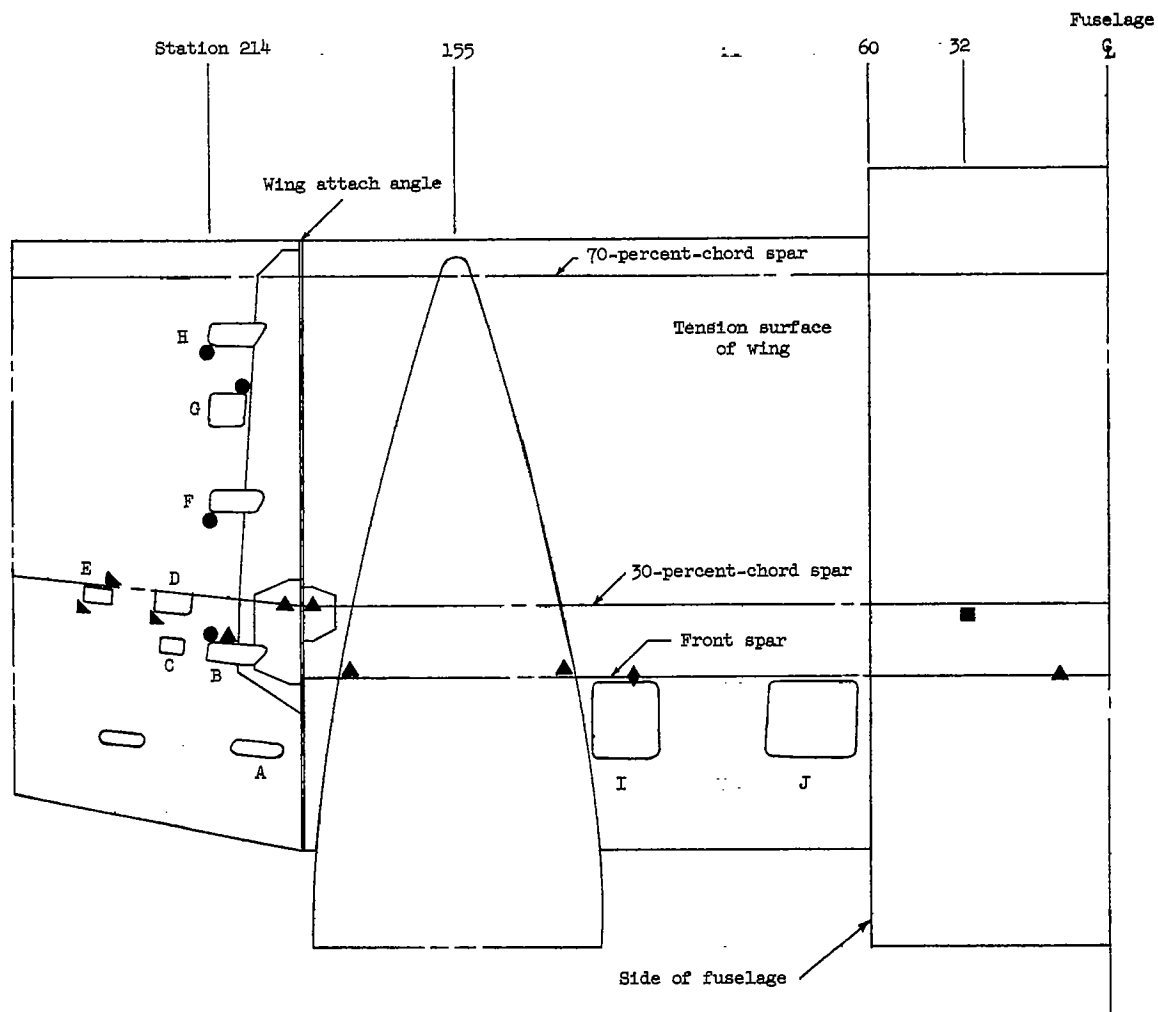
Figure 5.- Locations and types of fatigue failures.

The five types and their locations are shown in the plan view of the tension surface in figure 5, and are illustrated in figures 6 and 7. Most of these types of failures occurred in stress raisers which would be present in similar form on almost any metal aircraft structure.

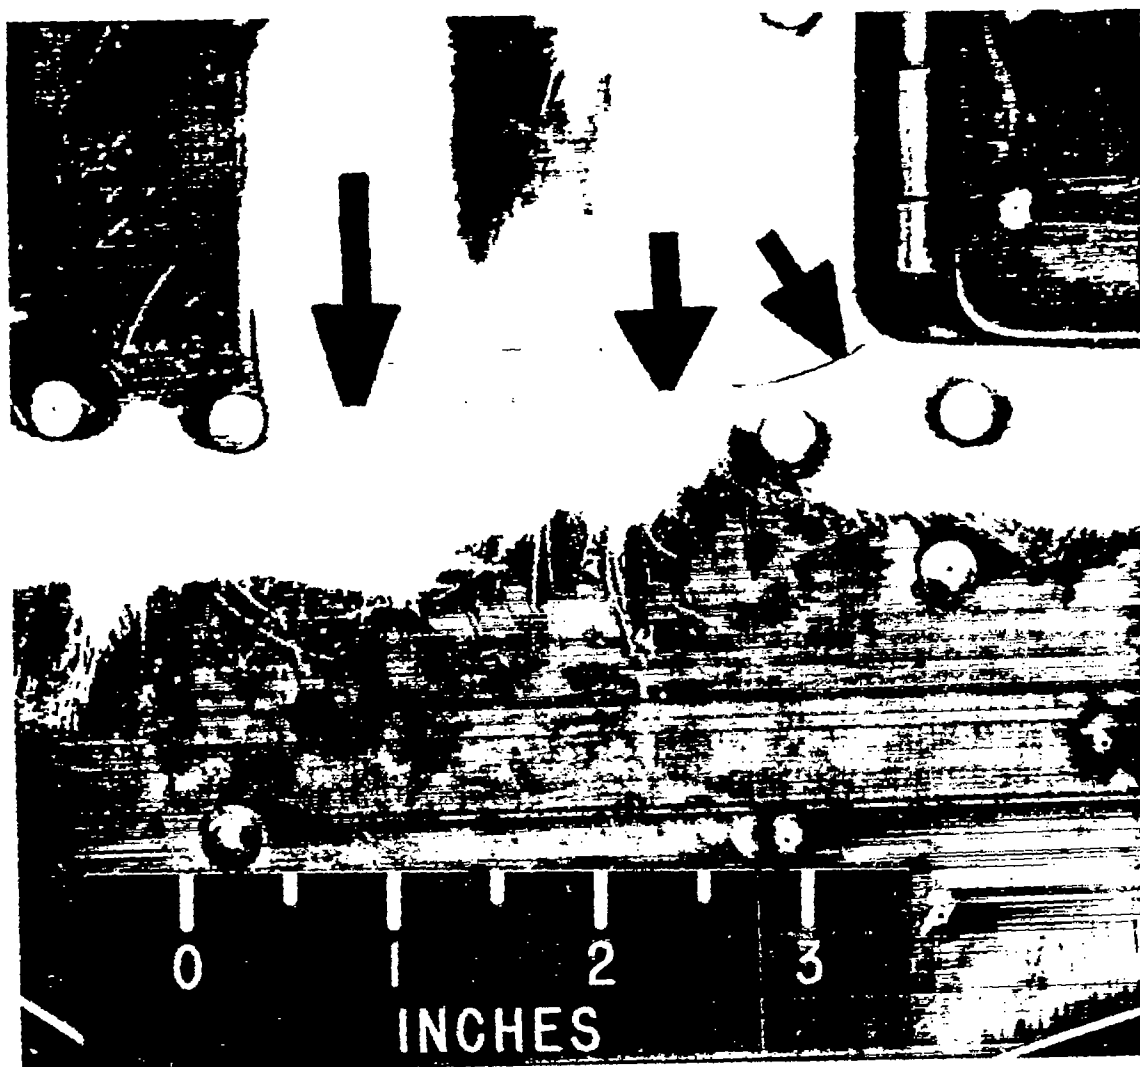
L-77922.4

The type I failures originated in the corners of inspection cutouts B, F, G, and H, and examples are shown in figures 6(a) and 6(b). These cutouts had non-load-carrying covers and were all at span station 214. Most of the failures occurred in the vicinity of the spar at the 30-percent-chord position, which was the most highly stressed region as indicated by the chordwise stress-distribution survey at this station. Since span station 214 contained numerous cutouts, doublers, and other discontinuities and therefore yielded an irregular stress distribution, another chordwise survey was made at span station 235, which was the nearest station that was free of these discontinuities. The gages used in these surveys were oriented so as to measure the strain in a spanwise direction. The results of these surveys are presented in figure 8, along with a cross section of the tension surface at span station 214. This figure indicates that for both of these stations the highest stress occurs in the vicinity of the 30-percent spar.

(a) Type I failure at forward outboard corner of inspection cutout F.

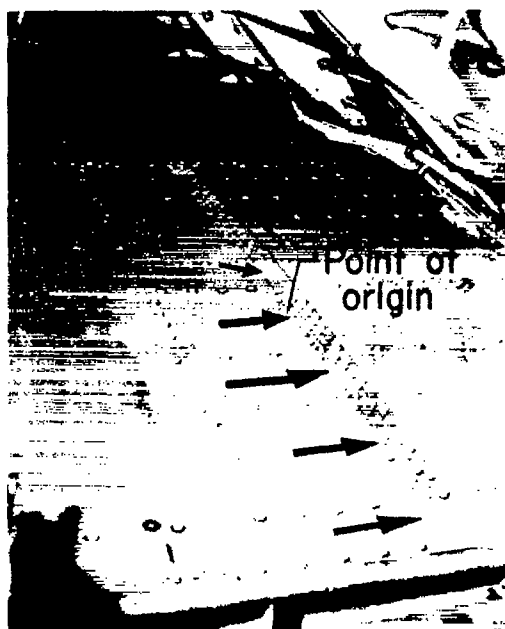
L-65799.2

The type II failures, which originated in riveted tension joints, all occurred at span station 32 inside the fuselage in the vicinity of the 30-percent spar. A photograph of this type of failure is shown as figure 6(c). A chordwise distribution of stress at span station 32 was included in reference 1 and indicated that the higher stresses again occurred in the vicinity of the 30-percent spar. These failures were consistent during the earlier tests but did not occur during the later tests because of the reinforcing strip previously described.

(c) Type II failure in riveted tension joint.

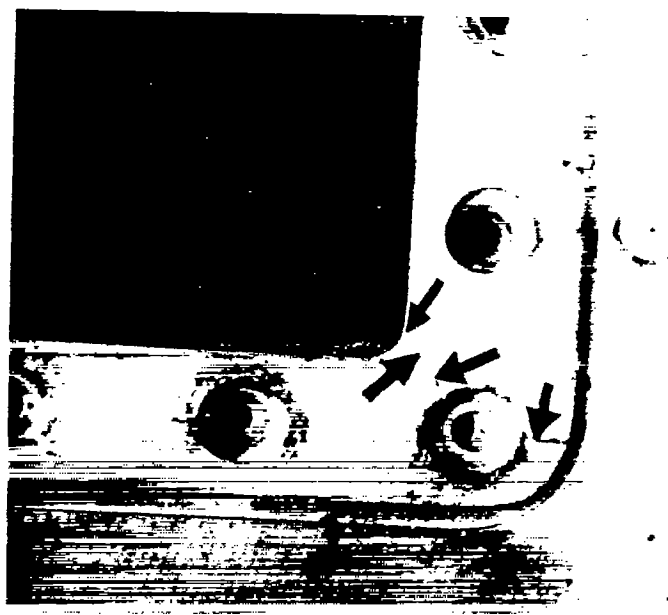
The type IV failures occurred in internal reinforcing doubler plates around cutouts D and E, located outboard of span station 214 and immediately forward of the 30-percent spar. A photograph of this type of failure is presented as figure 6(d). These cutouts had cover plates that were fastened to the reinforcing doubler plate with machine screws and channel nuts. The failures originated in the screw holes on some wings and in the smaller-radius corner of the internal doubler plate on others, frequently occurring very early in a test. These failures spread into the skin on only two occasions but in no case did they grow to more than a few inches in length.

(d) Type IV failure in reinforcing doubler plate at inspection cutout D. L-77924

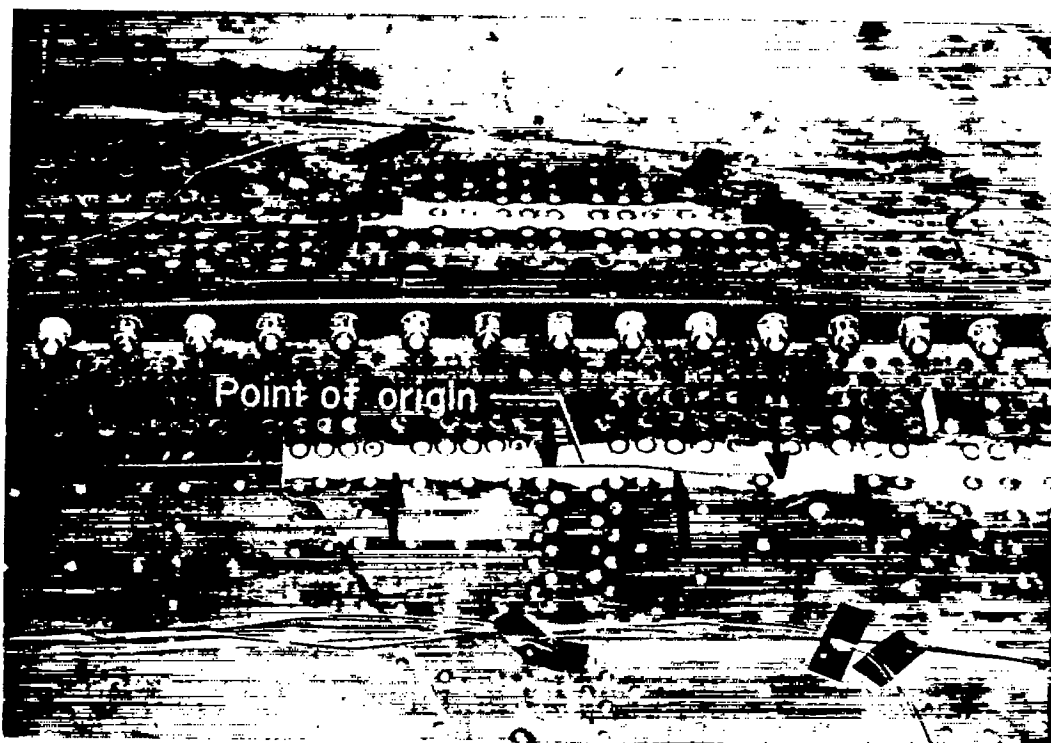
(e) Type V failure in joggle in external reinforcing doubler plate. L-67351.1

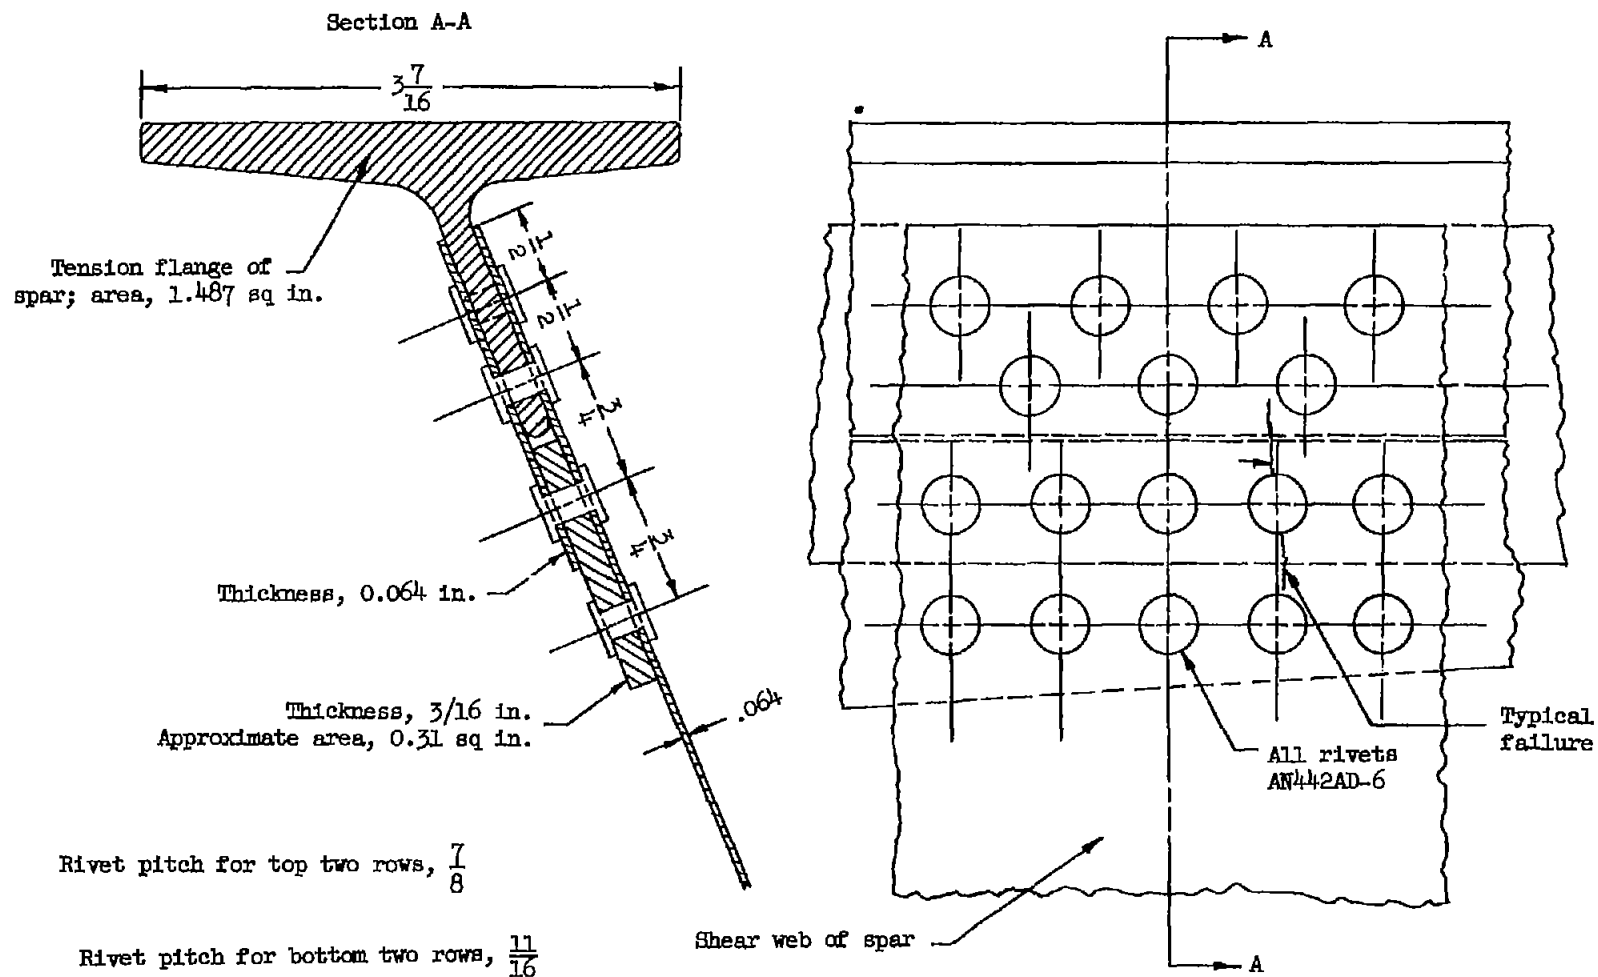
Figure 7.- Details of riveted shear joint at span station 120 in which type III failures occurred.

The type III failures occurred at span station 120 in the riveted joint connecting the shear web to the tension flange of the front spar. Since this location was very difficult to photograph, a drawing of the details of this joint is shown in figure 7. The cracks usually progressed vertically through the shear web and were accompanied by a crack in a small piece of skin over the spar cap.
